# High-density PCB with BGA-IC In-circuit tester WTX-3000 (SX)

WILLTECH Co., LTD

# The generation change of the In-Circuit Tester

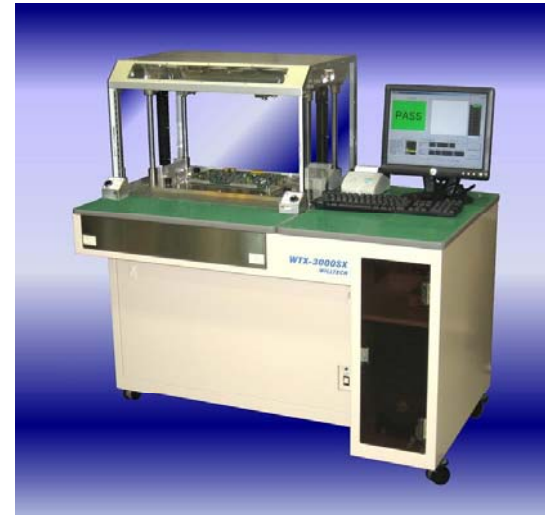
- **PGP-Fixture**
- **All nodes probing of very high accuracy**
- **QFP,BGA-IC Lead Open detect**
- **Low stress press**
- **Recovery of the Contact fail probe**
- **Traceability environment**
- **Re-work station construction**

In the test process of High density print board by the conventional ICT, there was generating with mounting fault outflow and large false fault in the factory. As a result of our investigating a cause, in ICT present in use, it turns out in measurement functions, FIXTURE accuracy, and all the PRESS mechanisms that it cannot deal with high density like Digital equipment print board, and a high-speed print board. Based on the proposal of WILLTECH, WTX-3000 of ICT made from WILLTECH were adopted, the High density PCB correspondence FIXTURE was manufactured, and evaluation of fault detection capability and inspection stability was performed in the factory.

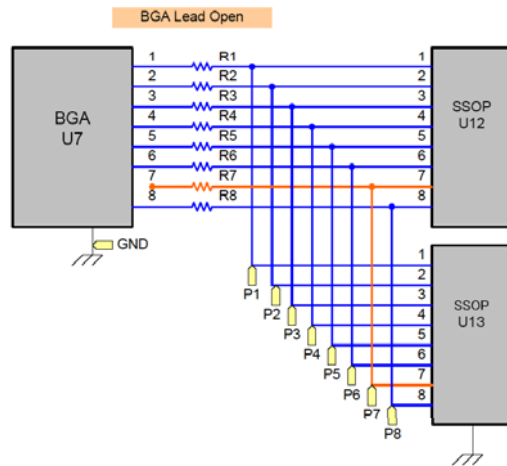
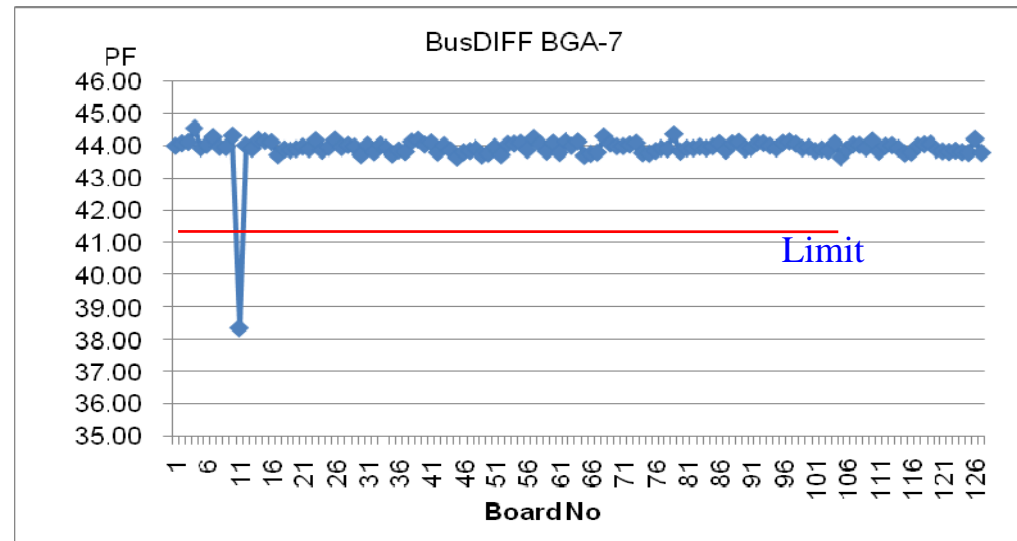
# QFP,BGA-IC Lead Open detect

NET with IC,s  
U7 (BGA) Output C 4.8PF(TYP)  
U12 (SSOP) Input C 5.0PF(TYP)  
U13 (SSOP) Input C 5.0PF(TYP)

Bus DIFF Test function detects an IC open defect by detecting the little change of the capacity impedance of the print board NET pattern. The capacity of the NET pattern is decided by the capacity of the IC lead terminal connected with the pattern capacity of the print circuit board and the pattern. When an IC lead terminal pin is a un-connection (an open defect), it is decided that the capacity that it is equivalent to the pin decreases, and it can be detected as an open defect.

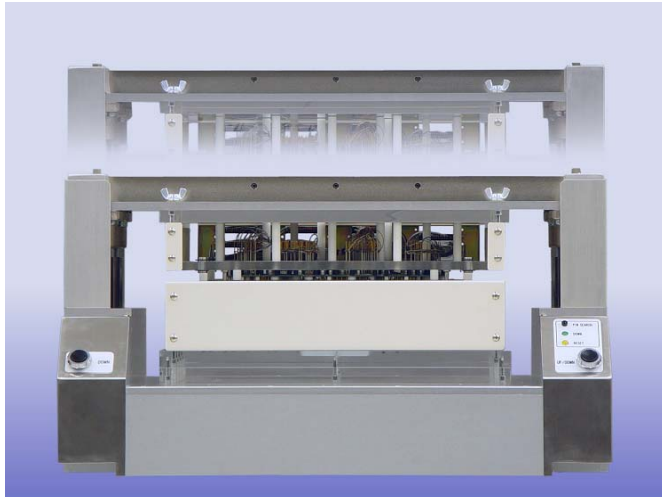
## A high precision Two(2) axis Press unit

- AC motor soft press
- Non Pressure Air
- Two axis equality drive
- Press parallelism 0.3mm
- Low stress to Test PCB
- PGP Fixture

Two axis drive press of both sides was developed for the purpose of restraining stress to a board. And a guide plate prevents distorted of a board by probe density imbalance. In addition, a probe is protected in a board set with a guide plate. Because a board comes in contact with a probe at the final stage of press, it is not to be damaged with a board and a probe

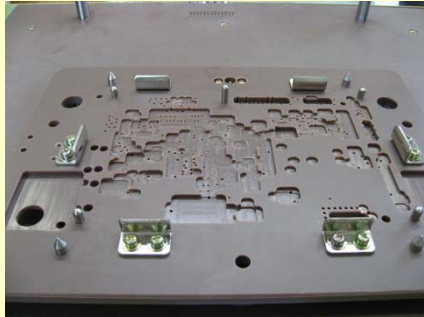
## Very high accuracy PGP Fixture

Division	Item	standard
Structure	Fixture Method	A probe guide plate (PGP)
	Materials	High hardness Engineering plastic
Probing performance	Accuracy of the probe tip	$\pm 0.1\text{mm}$ (max)
	Probing pitch (standard)	1.27mm (min) 1.00mm (Special order)
	Stress to a print board (maximum)	$-250 \times 10^{-6}$ (max) strain
Minimum probe point	QFP-IC	Lead pitch. 0.4mm (min) Pattern width. 0.2mm (min)
	VIA hole	$\Phi 0.25\text{ mm}$ (min)
	TEST PAD	$\Phi 0.3\text{mm}$ (min)
	SMD Chip	1005 (min)
	SMD Chip pattern	$0.3 \times 0.3\text{mm}$ (min)

A print board becomes high integration, and implementation technology advances. However, it is difficult to keep implementation reliability by production inspection and becomes a big problem. I developed the probe guide plate (PGP) method that was ICT Fixture corresponding to production inspection of high-density implementation board in the future in a will technical center. The PGP Fixture shows distinguished performance in a fail rate of detection, test probe contact stability, stress reduction to a high density of thin PCB and test probe protection.

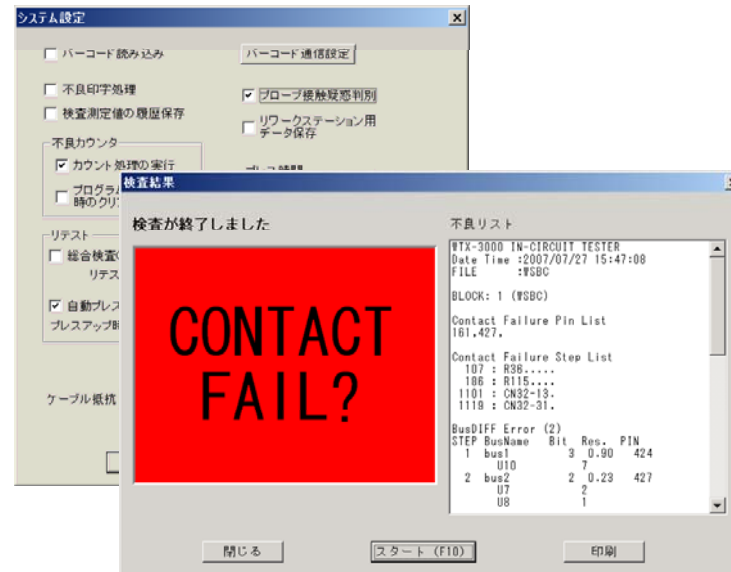
# Recovery of the Contact fail probe

We understood that test probe and poor contact of a Print board were caused by an alien substance (a dirt and an oxidation embrace) of the probe tip. It was admitted that occurred by 50 times of contact, and This Alien substance (a dirt and an oxidation membrane) became a factor to let you obstruct reliability of the In circuit tester..

As for the strong flux, outbreak of the poor probe contact is predicted.

The poor contact distinction function displays a connection part related to probe number that it seems that the contact of the probe is poor and it as contact defectiveness
